**Flood Control Project Maintenance
Levee Inspections****LMA District Cover Sheet****Spring 2015 Levee Inspection Results****Reclamation District No. 2064 River Junction**

Spring 2015 Levee Inspection Results

Reclamation District No. 2064 River Junction

Waterway			Bank	Unit Miles
Unit No. 01 San Joaquin River			Right	5.56
	Spring (March - May)	Summer (June - August)	(September - November) Fall	Winter (December - February)
Unit Maintenance Rating (Fall Only)				
Date of Inspection	04/21/2015 - 04/21/2015			
DWR Inspector	Herman Phillips			
Accompanied By	Gordon Armstrong RD 2064 President

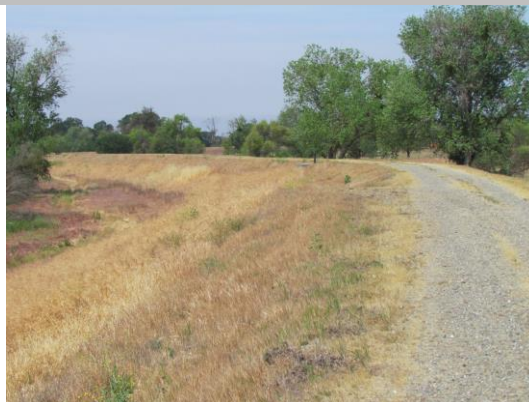
Photo 1 of 1 : SP_2015_RD2064_313_26_20150604_00010.jpg

LM Start	1.59	Rating **	U	Issue No.	26
LM End	1.65	Issue Type +	Ma	Location *	WS
Category	Earthen Levee			GPS Latitude/Longitude	
				Start	End
Item	Vegetation			37.690678 °	37.690067 °
				-121.270525 °	-121.269865 °
DWR ID	DWR_RD2064_01_s _ 2015_26				
Action/Comments					
Remove the wild growth other than native grasses from the levee slopes.					
Inspector Comments: Control the unacceptable weeds on the waterside levee slope.

View looking downstream at unacceptable weeds on the levee slope.

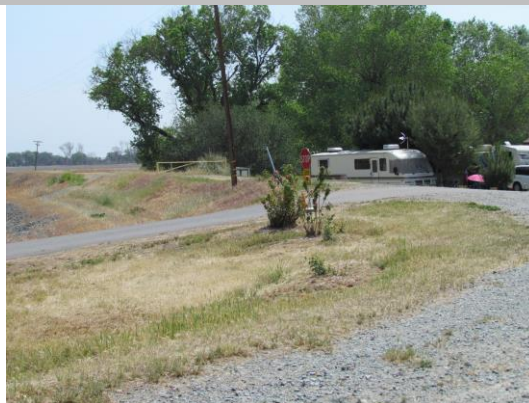
Photo 1 of 1 : SP_2015_RD2064_314_2_20150604_00014.jpg

LM Start	0.00	Rating **	M	Issue No.	2
LM End	5.89	Issue Type +	Ma	Location *	LS
Category	Earthen Levee			GPS Latitude/Longitude	
				Start	End
Item	Vegetation			37.667068 °	37.704049 °
				-121.240899 °	-121.181042 °
DWR ID	DWR_RD2064_02_s_2012_2				
Action/Comments					
Control annual grass and weeds on the levee slopes and easements.

View looking downstream at the landside slope.

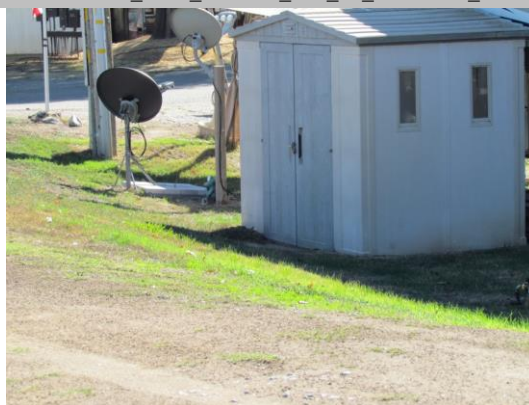
Photo 1 of 1 : SP_2015_RD2064_314_30_20150312_00005.jpg

LM Start	0.01	Rating **	M	Issue No.	30
LM End	0.01	Issue Type +	En	Location *	WS
Category	Earthen Levee			GPS Latitude/Longitude	
				Start	End
Item	Encroachments			37.666927 °	37.666927 °
				-121.240807 °	-121.240807 °
DWR ID	DWR_RD2064_02_f_2014_30				
Action/Comments					
Building					
Inspector Comments: Unauthorized building, satellite disk and concrete pad placed on waterside toe without a CVFPB Permit.

Looking downstream from waterside at unauthorized building and satellite dish on levee toe.

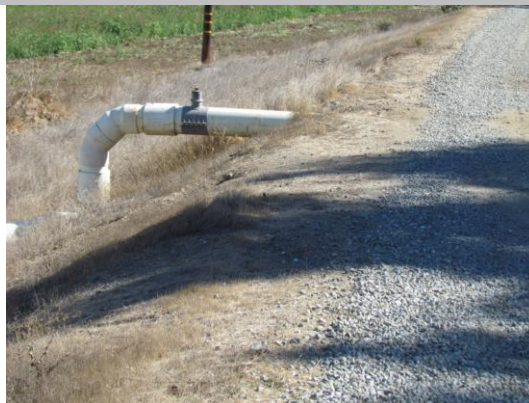
Photo 1 of 2 : SP_2015_RD2064_314_26_20150312_00003.jpg

LM Start	0.33	Rating **	M	Issue No.	26
LM End	0.33	Issue Type +	En	Location *	CR
Category	Earthen Levee			GPS Latitude/Longitude	
				Start	End
Item	Encroachments			37.664767 °	37.664767 °
				-121.236497 °	-121.236497 °
DWR ID	DWR_RD2064_02_f_2014_26				
Action/Comments					
Pipe

Looking downstream along the landside at an unauthorized pipe.

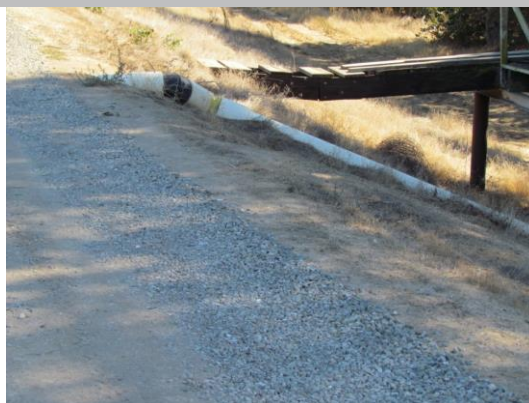
Photo 2 of 2 : SP_2015_RD2064_314_26_20150312_00004.jpg

View looking downstream at unauthorized pipe work through the levee section. No CVFPB permit on record for this work.
